DESIGNER'S WALK

By DAVID LANDY ASID, CID NY STATE
PRESIDENT ELECT ASID NY METRO

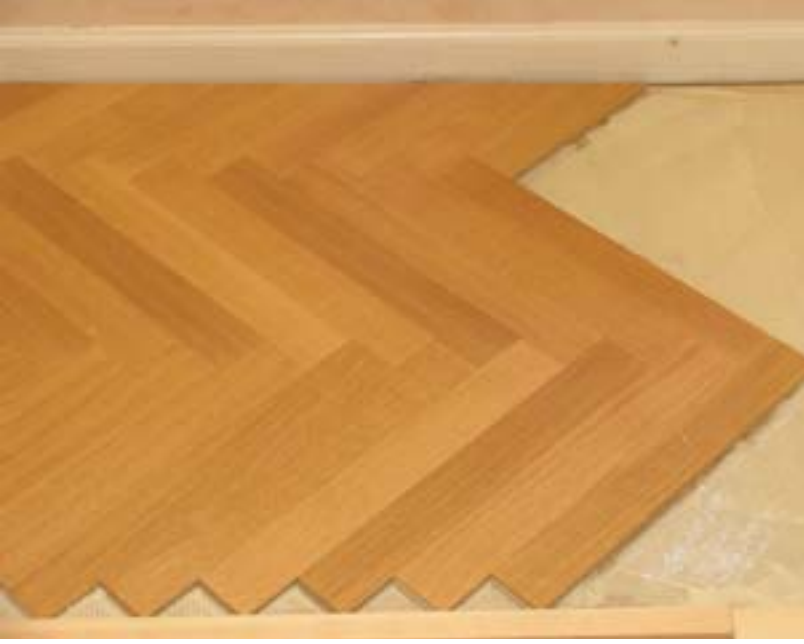
Real herringbone is a painstaking process but worth the outcome, above.

Though we first fell in love with the creamy yellow tone of the wood, its beauty was enhanced by a painstaking installation. Our installer used a small-notch trowel to sparingly apply adhesive so none could ooze through the tongue and groove fittings. Each piece was individually cut with a bandsaw and fit.

Why herringbone? I wanted something different starting with the entry hall. If the lines went straight, the hall would appear too long. Setting it at 90 degrees means we'd run into the same problem once the hall made its turn. We opted first for a diagonal. However, the ever-adventurous owner agreed on the bold herringbone I'd seen at the museum. Instead of a three-day installation, it took nearly 10, but it was worth it.
